Barry Hunt & Bruno Miglio<sup>1</sup>

# DETERIORATION OF STONE FLOORS

*The authors look at some of the reasons why stone floors may deteriorate and suggest ways in which the problems may be avoided.*

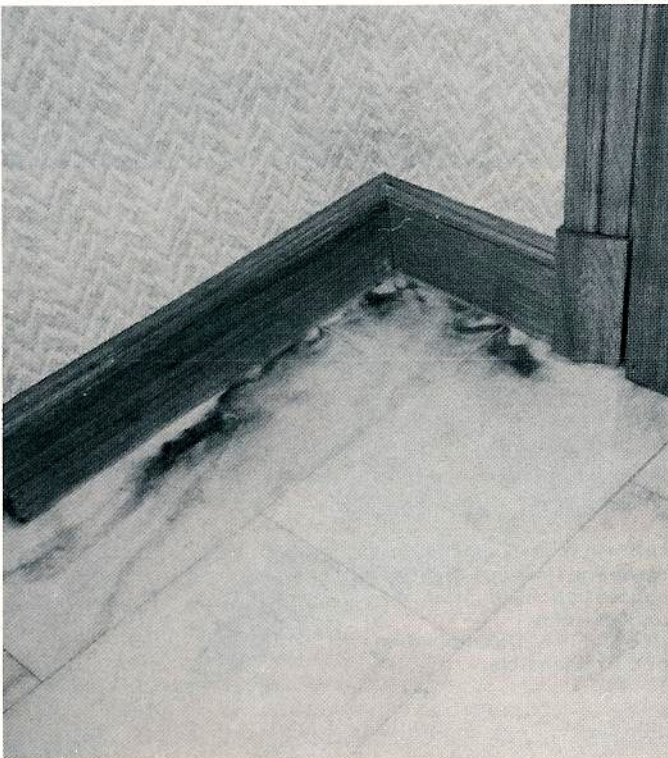
**Fig 1: Spread of organic materials from wooden skirting due to attack by cleaning fluids.**

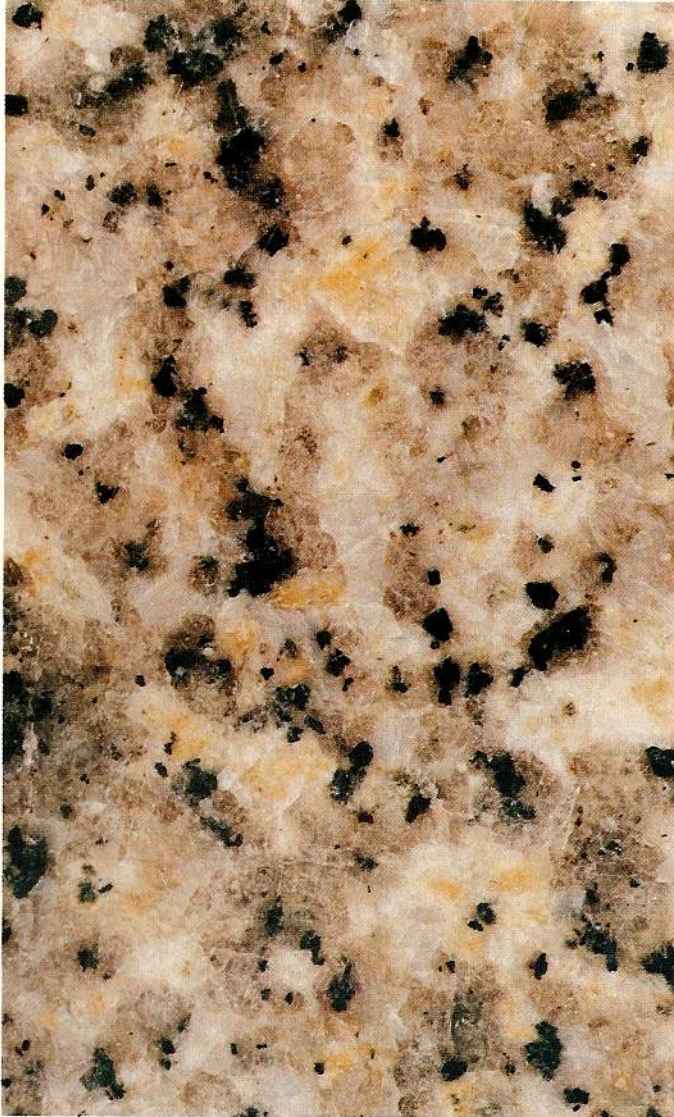
**Below: Fig 2. Discolouration from white to orange of feldspar crystals at the polished surface of a granite. Magnification: x 2.**

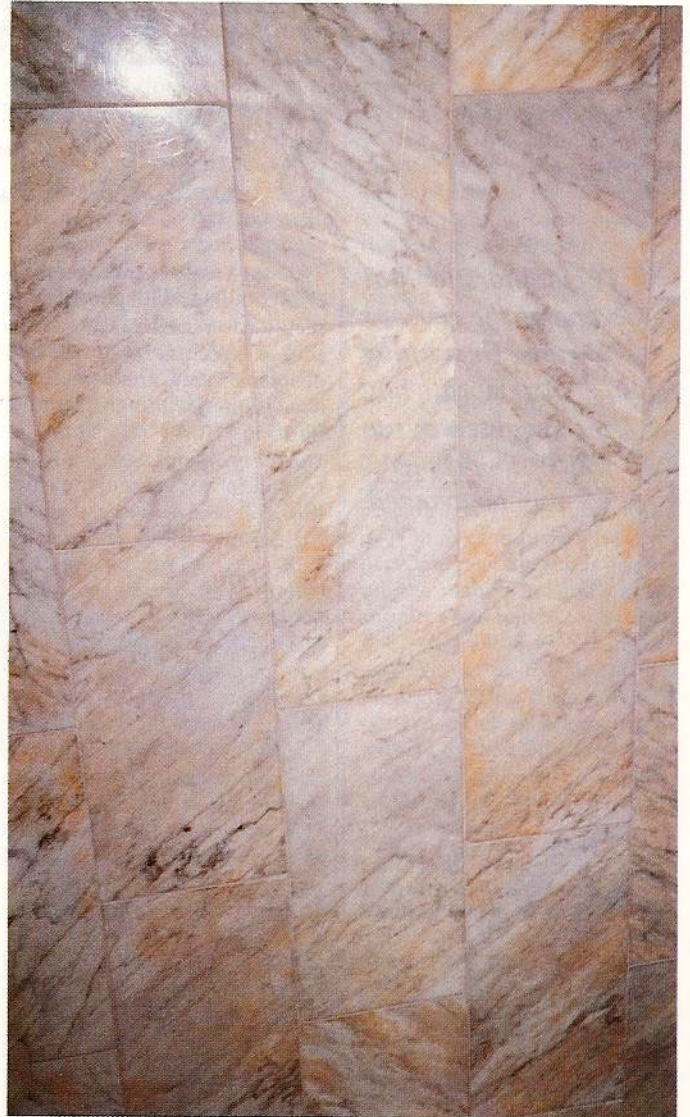
**Right: Fig 3. Discolouration of Carrara-type marble floor.**

icularly discolouring. The highest quality Carrara marbles are pure white grading down to shades of grey. Close examination of the veins and spots, and the body of the greyer marbles reveals the presence of an increasing proportion of iron sulphide minerals, usually as grains below a thousandth of a millimetre (one micron) in size. It appears that alkaline solutions (possibly drawn from underlying cementitious bedding materials) and strongly oxidising agents such as bleach and some other floor cleaners may be able to react with the iron sulphides. Due to the light colour of the marble even the smallest release of iron in the form of ferrous oxides can cause a dramatic change in colour. The form of the ensuing discoloration can be highly variable due to changes in crystal density, size, permeability, and content of discoloring material. Often the veins contain the highest content of deleterious constituents and appear to be the most stained areas of the stone. (see fig. 3)

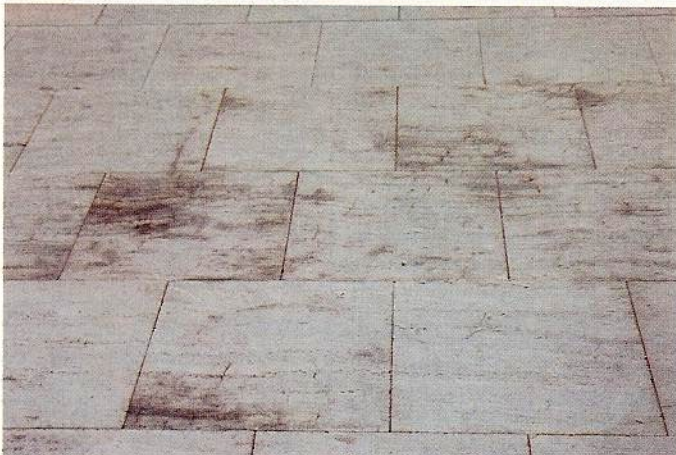
**Left: Fig 4. Dark patches in a travertine floor due to different concentrations of dirt in unfilled voids. Above. Fig 5. Discolouration of Carrara marble.**

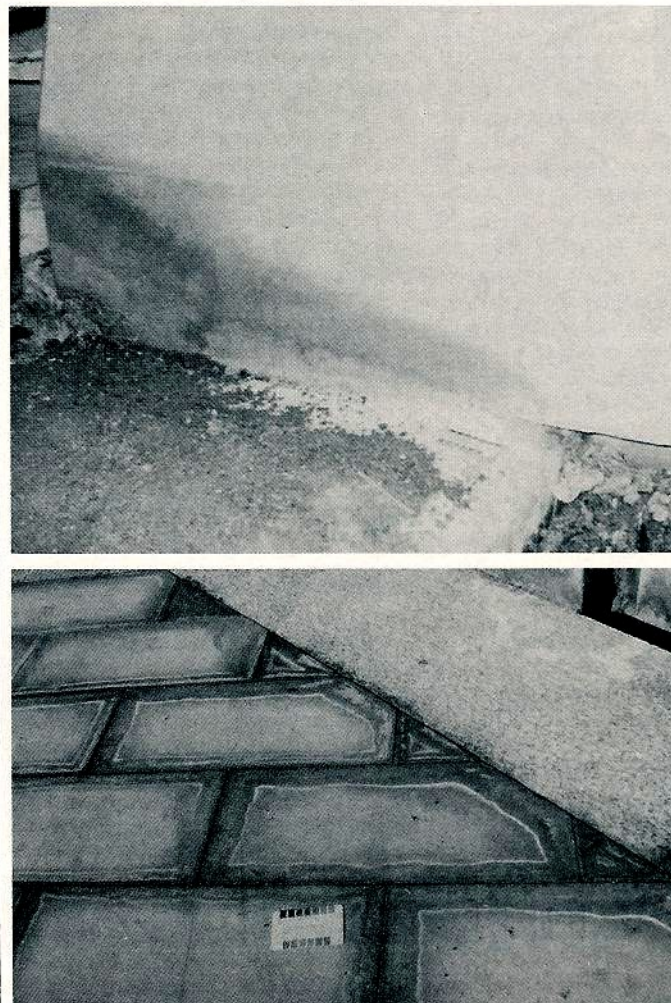
Bottom: Fig 7. Efflorescence associated with moisture release at joints.
