# The Use of Fluorescent Dyes in Highlighting Some Construction Problems

Barry J. Hunt

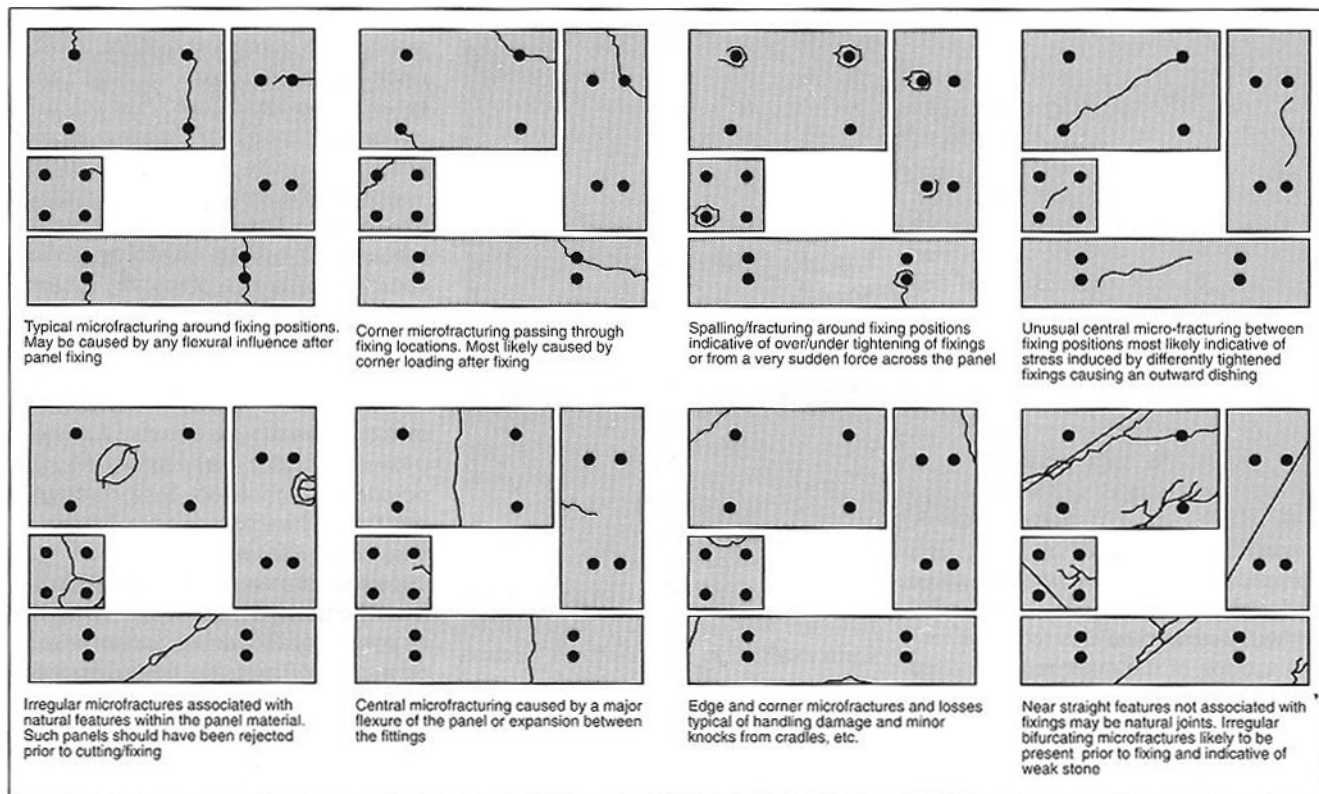
Figure 1. Different Crack Styles for Thin Stone Panels Which Have Been either Face-fixed or Invisibly Bolted. Typical Fixing Locations Are Indicated by the Four Dots. Crack Styles for Other Fixing Systems May Be Considerably Different

Microfractures were found to be associated with fixing positions but closer examination suggested that some of the microfractures were present prior to blast effects. A summary of idealized crack styles is given in Figure 1. Where microfractures are identified, they should undergo careful visual inspection in good light to identify whether the cracks contain dirt (indicative of old age) or are chibbled, a term coined to describe the smoothing and/or loss of crack edges. Chibbling is indicative of an old crack that has had time to deteriorate by any combination of heating/cooling, wetting/drying and freezing/thawing cycles. Fresh cracks still exhibit partially attached chips at crack edges.

From my own investigations of blast-affected stone panels, it was evident that some panels were cracked prior to the blast, as a result of either general handling during construction, original use of poor quality materials, uneven tightening of fixings across a panel or any combination of these factors. The features identified may have been insignificant prior to the blast, possibly being exploited by it to produce further damage. Some of the pre-blast damage identified highlighted problems of quality control with the original construction. Furthermore, some of

Dye testing can be used quickly on panels prior to fixing or even cutting in the stone yard to determine the presence of cracking or natural features that may indicate lines of weakness. Considering that uncut stone slabs may be worth in the region of several thousands of pounds, rejection of inferior materials at this stage becomes highly cost-effective for the purchaser. A second check can be carried out once the stones have been fixed to guarantee the workmanship and prevent the creation of potentially lethal situations.

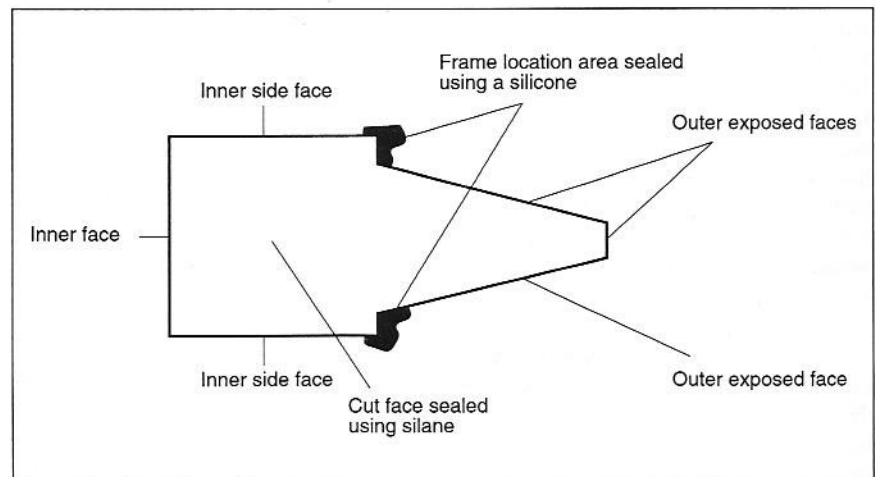
After ten minutes' partial immersion, the dye was visible at the bases of the untreated internal side faces; 45

minutes into the test, the dye had reached the innermost surface, having risen up the majority of both inner faces. The moisture rise clearly exploited zones of higher microporosity owing to very localized variations in compaction. Thin crack features also became visible during the test, the dye also exploiting such conduits. After two hours, the mullion unit was almost completely saturated.

The simple test demonstrated how rapidly moisture could be transmitted through reconstructed stone, damp occurring internally where the design was inappropriate rather than the material itself failing. Reconstructed stone products are notoriously difficult to test, with great variability in the results often having been found. The test highlighted the manufacturing variability, particularly differences in compaction which would explain such results.

Figure 2. Cross-section of a Mullion Unit Used for Testing to Determine the Capillary Uptake of Moisture Incident on the Exposed Outer Faces through to the Unexposed Inner Faces
