# The

*When slate is put onto a roof it is expected to stay there, unchanging and maintenance free, for many years. Some recent failures of imported slate have cast a shadow over the material in general. But slate is still the best material there is for roofing. Barry James Hunt\* explains why.*

# changing face of slate

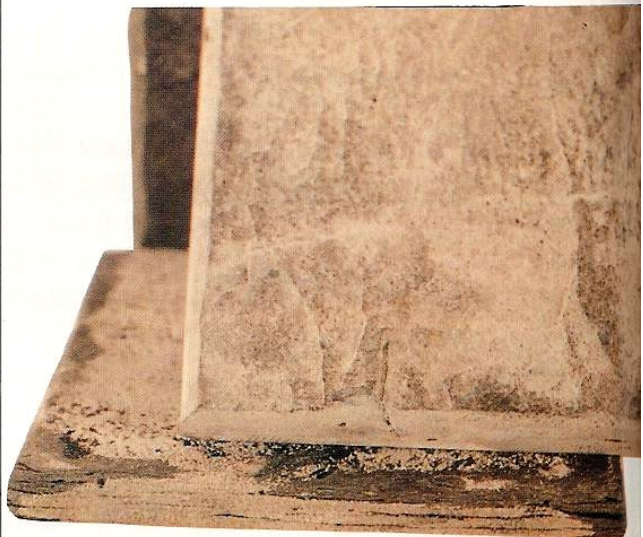
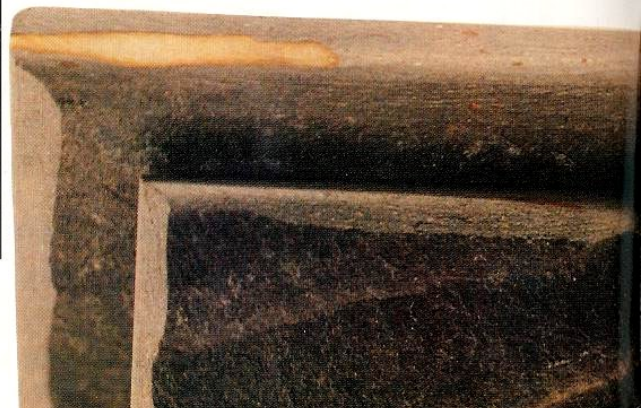
Some of the problems which can be encountered with slate. The picture at the top shows what happens when calcite inclusions burst as a result of mild acid attack. Above, the slate is showing signs of delamination as a result of acid immersion testing. And the slate below shows an area of discoloration during a wet/dry cycle of testing.

Where slates are found to have been in existence somewhere for hundreds of years, inspection of such a location often highlights their slow deterioration. Usually minor spalling, loss of edges, delamination or partial discoloration of pyritic components may have taken place. Where pyrite has discoloured, this is often found to be a surface oxidation with fresh pyrite just below the surface.

With respect to the problems with Spanish slate, those which have been found to have deteriorated have been incompletely metamorphosed material, exhibiting distinctive bedding structures. Some deterioration in-service has been attributable to the attack of calcite inclusions by acids borne in rainwater.

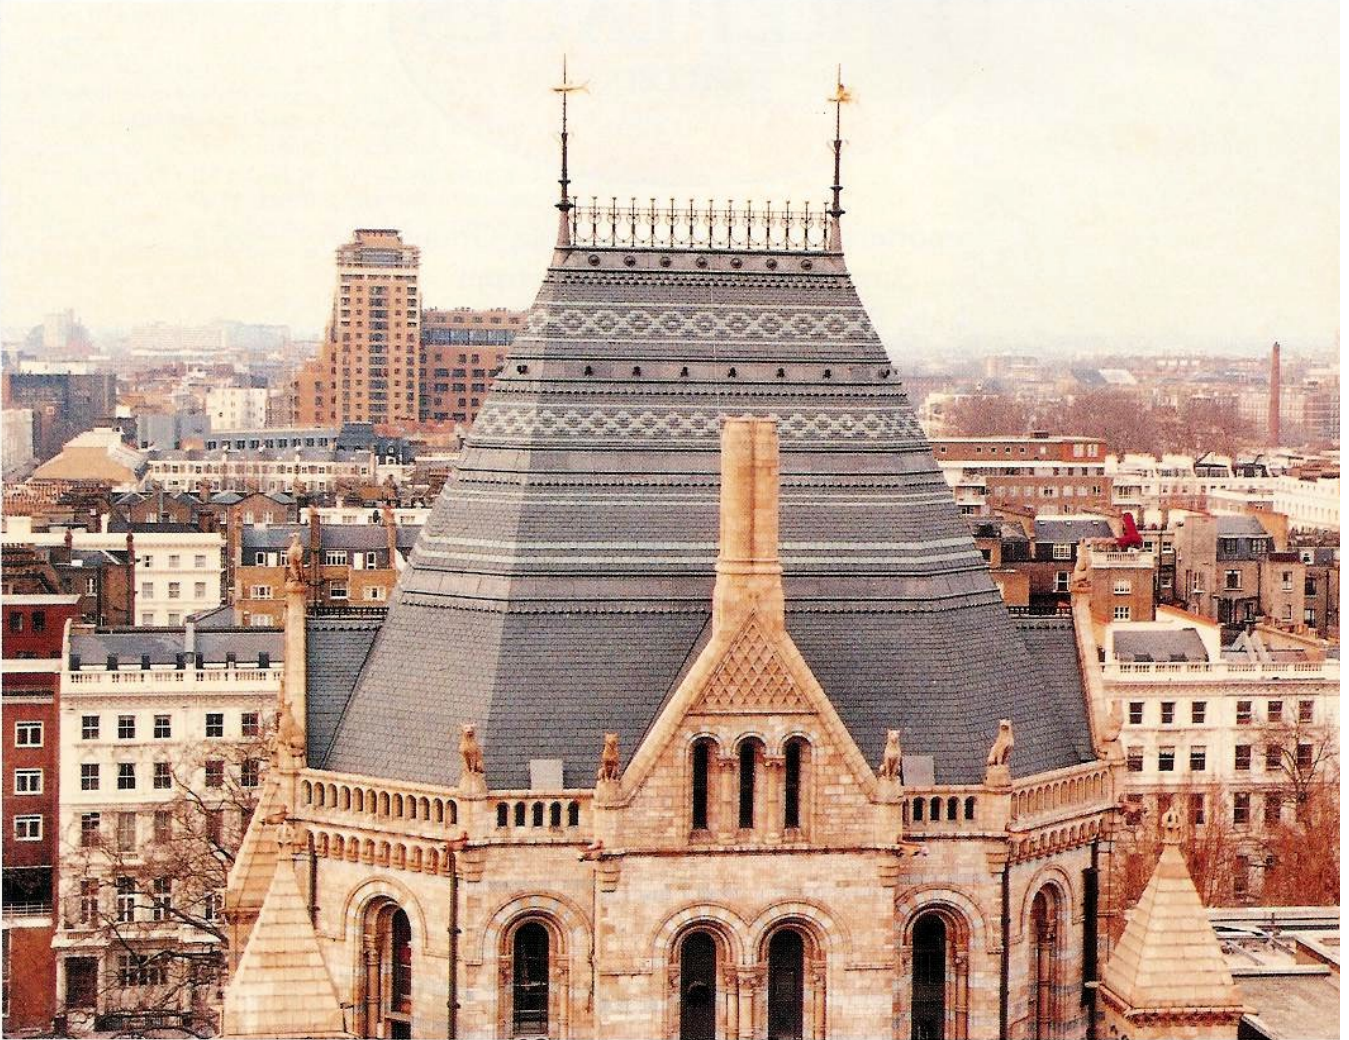
**Burlington blue/grey and Westmorland green roofing slates form a distinctive and striking pattern on the Natural History Museum, London. The slate was supplied by Burlington Slate.**

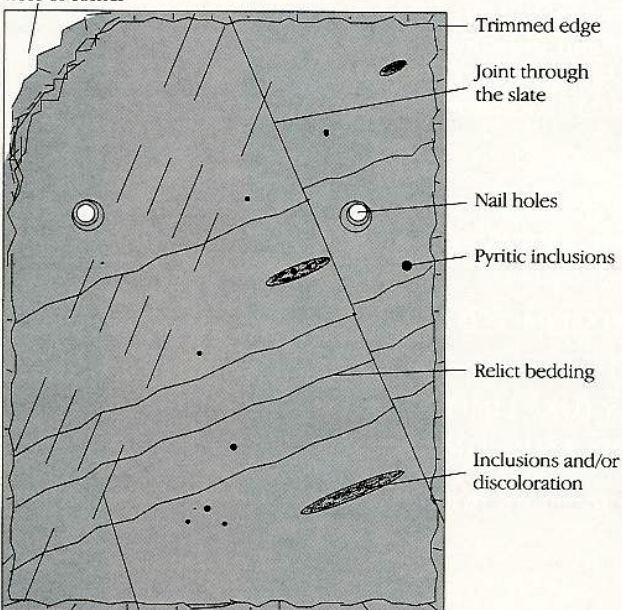
### General view of slate

Loss of corner

Traces of apparent grain
